No Metal-to-Metal Contact on Trumbull PRV's

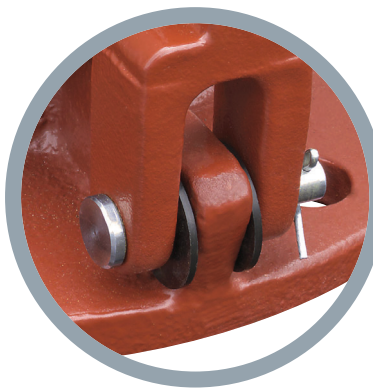
UHMWPE ISOLATING WASHERS
prevent metal-to-metal contact between lid and valve body on our ductile iron wall-type valves.

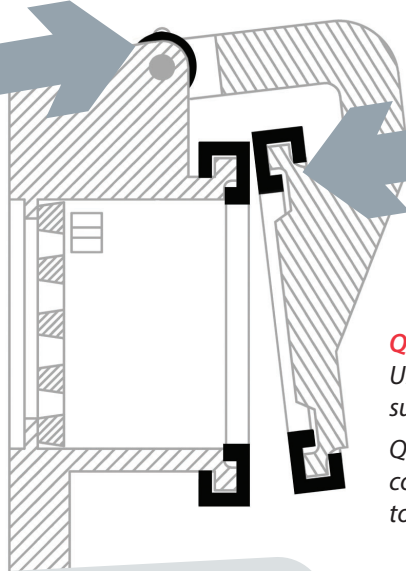
Alternate Design Wall-Type Pressure Relief Valve (as removed from service)

Flap was "frozen shut" by corrosion; the rim is caked with debris that has hardened.

RESULT: Inoperable valves cannot relieve groundwater pressure, leading to structural damage to tanks.

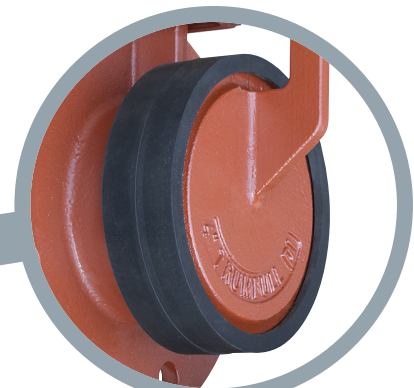
Valve after being pried open.

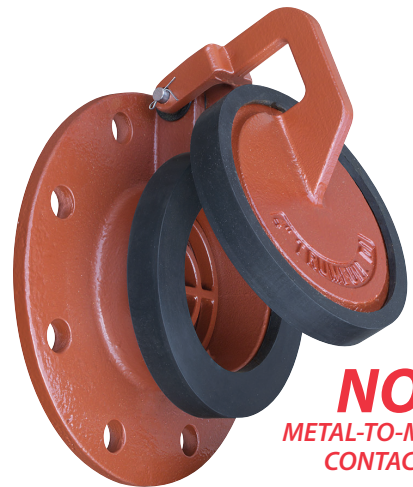
Wall-Type Pressure Relief Valve

NO METAL-TO-METAL CONTACT!

RESULT: Metal-to-metal contact is not possible between Trumbull seating surfaces!

It's because of our **QUADROSEAL** gaskets

QUADROSEAL GASKETS
Unique square design of Trumbull QuadroSeal Gasket surrounds casting on four sides to prevent separation. QuadroSeal design also prevents metal-to-metal contact that can cause seating surfaces of iron valves to corrode into a "frozen shut" position.
